Summary: Bodymaker main drive failure After separate isolated incidents of electrical fires occurring with the resistor enclosures on the Bodymaker control panels, it has been decided to introduce a new DC circuit breaker (Eaton Moeller CB PKZ-SOL12) to protect the circuit and to also physically disconnect all power from the Bodymaker main drive to the resistors under fault conditions. Also, an auxiliary contact has been added which is connected to the PLC input, this removes the 'drive enable' and 'run' signals (see circuit drawing below).

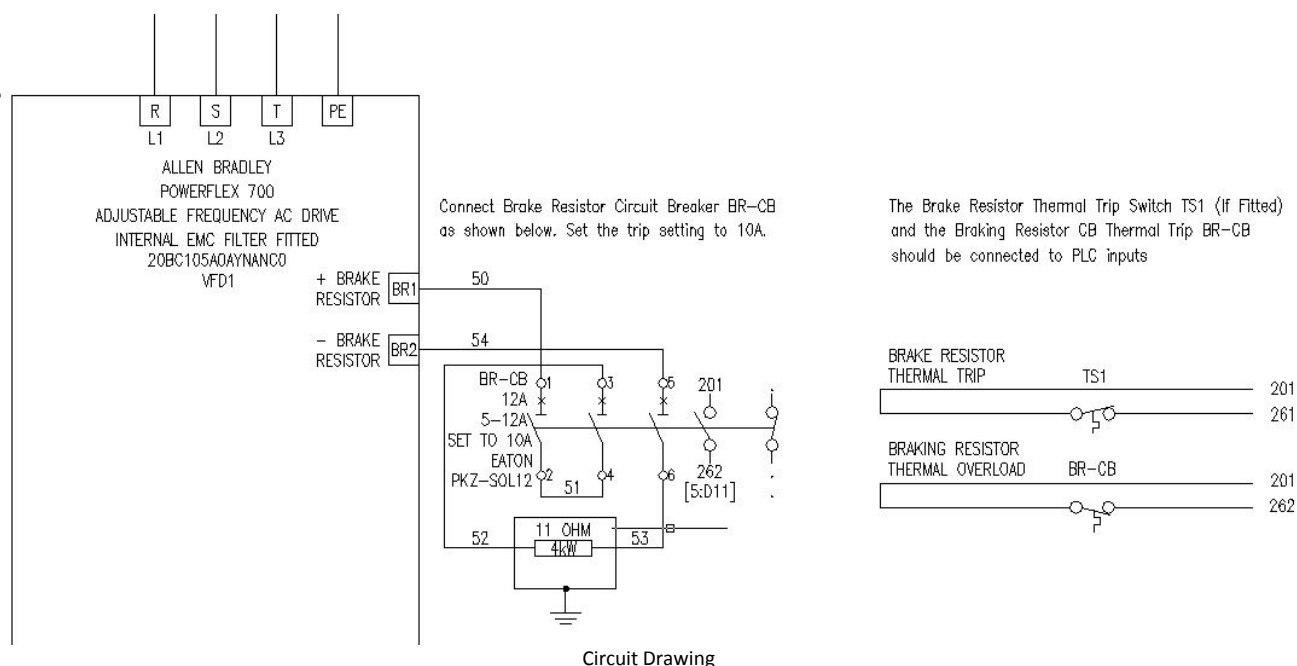
The issue occurs when the fault current is generated on Braking Resistor terminals BR1 and BR2 due to a faulty PF700. The braking resistors are not physically disconnected from the source of the fault by the overload protection device, which in turn, leads to the potentially high DC currents.

The modified circuit (Eaton Moeller CB PKZ-SOL12) has been rigorously tested under fault conditions. Results confirm that the correct electrical protection of the braking resistors has been achieved.

CarnaudMetalBox Ltd strongly recommend that this Technical Bulletin be implemented across all 5000 Bodymakers affected by this electrical issue. Please contact your sales [representative](#) for further information.
